V1.6 OG XBOX 1.4GHZ CPU V_CPUCORE Modifications

This document is solely for the purpose of adjusting the V_CPUCore voltage for a V1.6 Original Xbox with a **1.4GHZ TUALATIN CPU** installed. Make adjustments at your own risk.

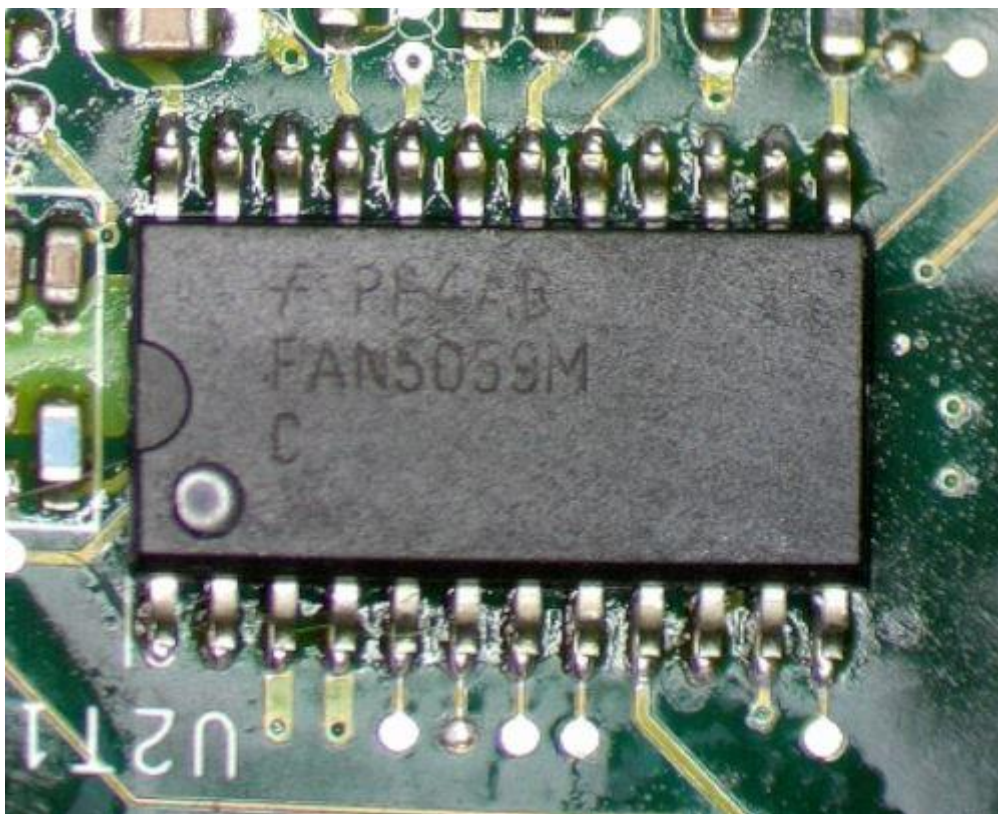
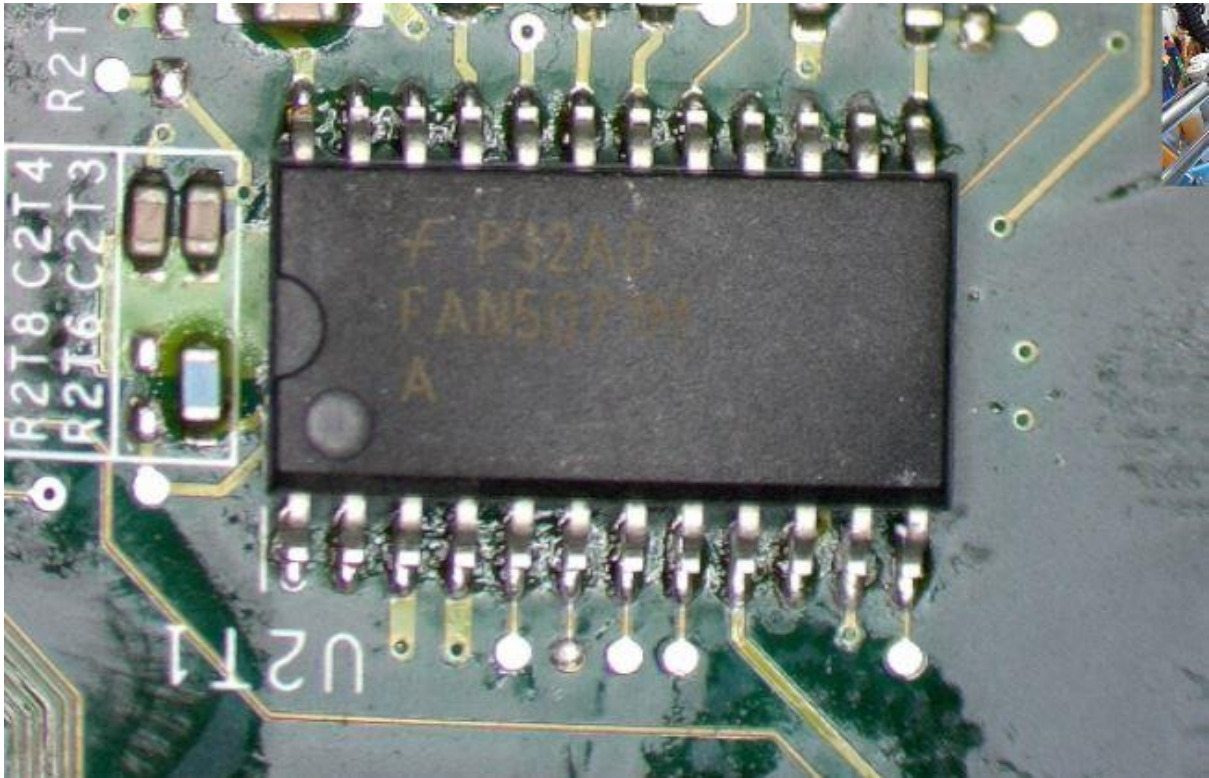
Firstly the OG CPU DC-DC regulator only supplies max 18W to the CORE and the TUALATIN PIII requires uses more than the OG regulator(FAN5059-U2T1) can supply to the upgraded CPU. The FAN5059 needs to be swapped out with an FAN5071 DC-DC regulator as it can supply up to 30W for the upgraded CPU.

STEP 1: Remove the current FAN5059 and replace it with an FAN5071 regulator. It is located on the underside of the board below the CPU area. Below is a picture of the FAN5059 and below that is the FAN5071 in it's place.

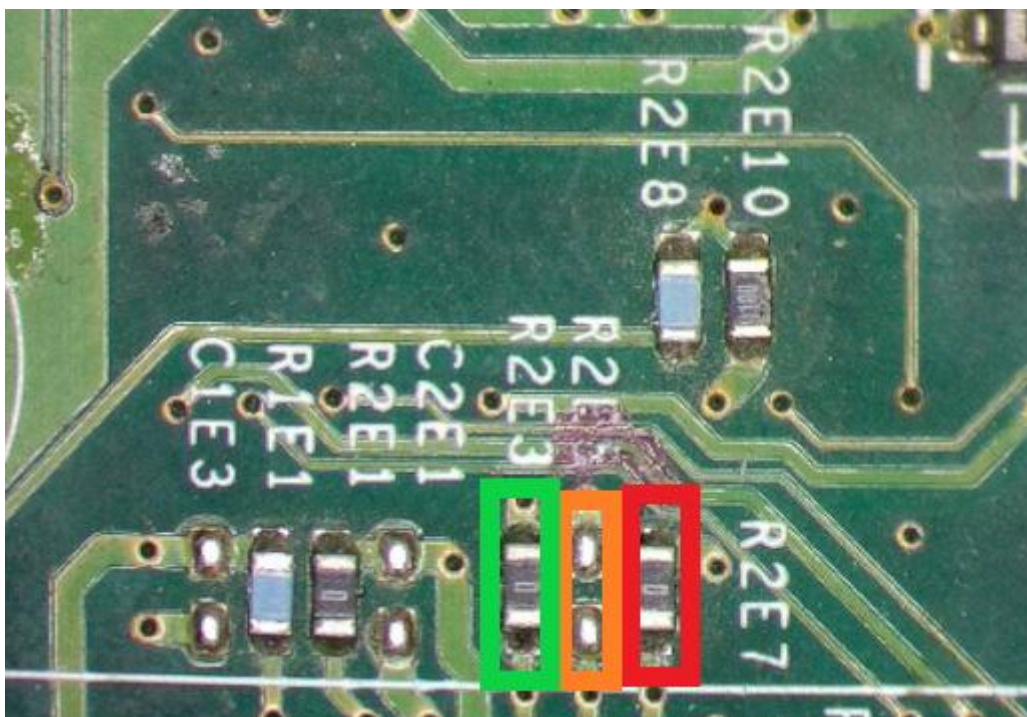
Run either of these 2 voltage adjustments to which the console runs stable. Findings show that some units do not like the lower 1.35VFB and games freeze on boot but run stable on 1.425VFB

STEP 2: Adjust the VFB VID lines to suit. *****(1.425V)** This requires removing the 0 ohm resistor from **R2E7** and moving **R2E3** to **R2E5**. *****(1.35)** This requires Removing **R2E7** and leaving **R2E3** populated.

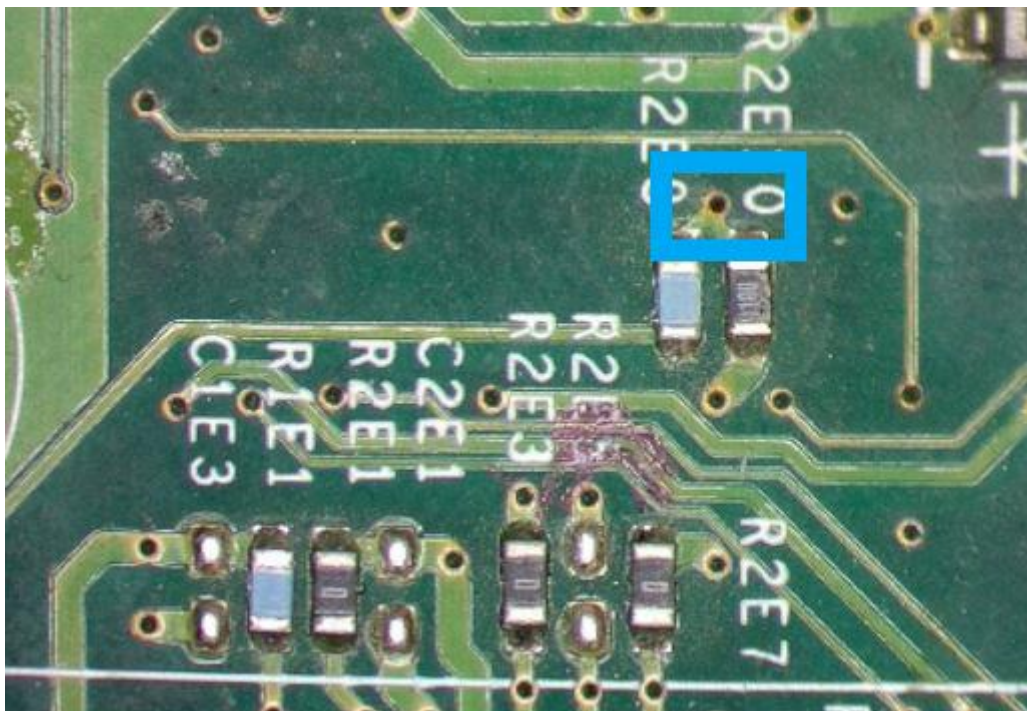
You should now have V1.33 at the VFB line and V1.37/8 at the CPU Core line. VFB can be tested at the [VIA](#) between R2E8 and R2E10. Or at the resistors themselves.

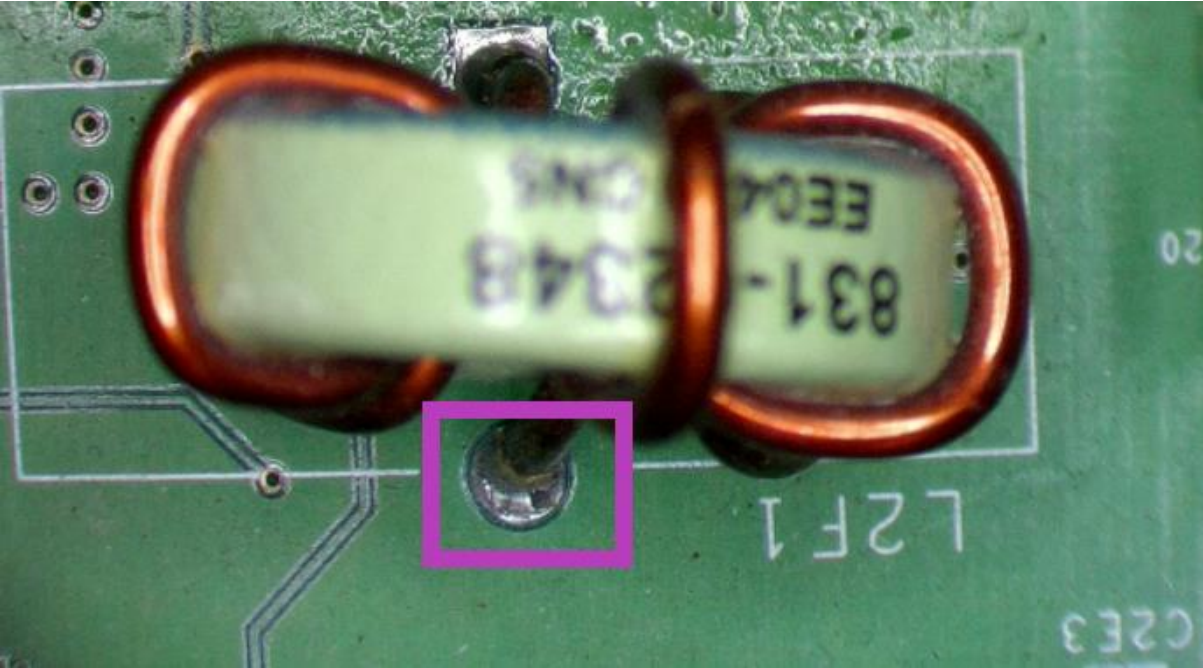
The CPU core voltage can be tested at the coil at L2F1 and should read V1.38-1.42 depending on the voltage adjustments you went with.
